WHAT'S WRONG WITH THIS PIC?

Topside with Capt Obvious

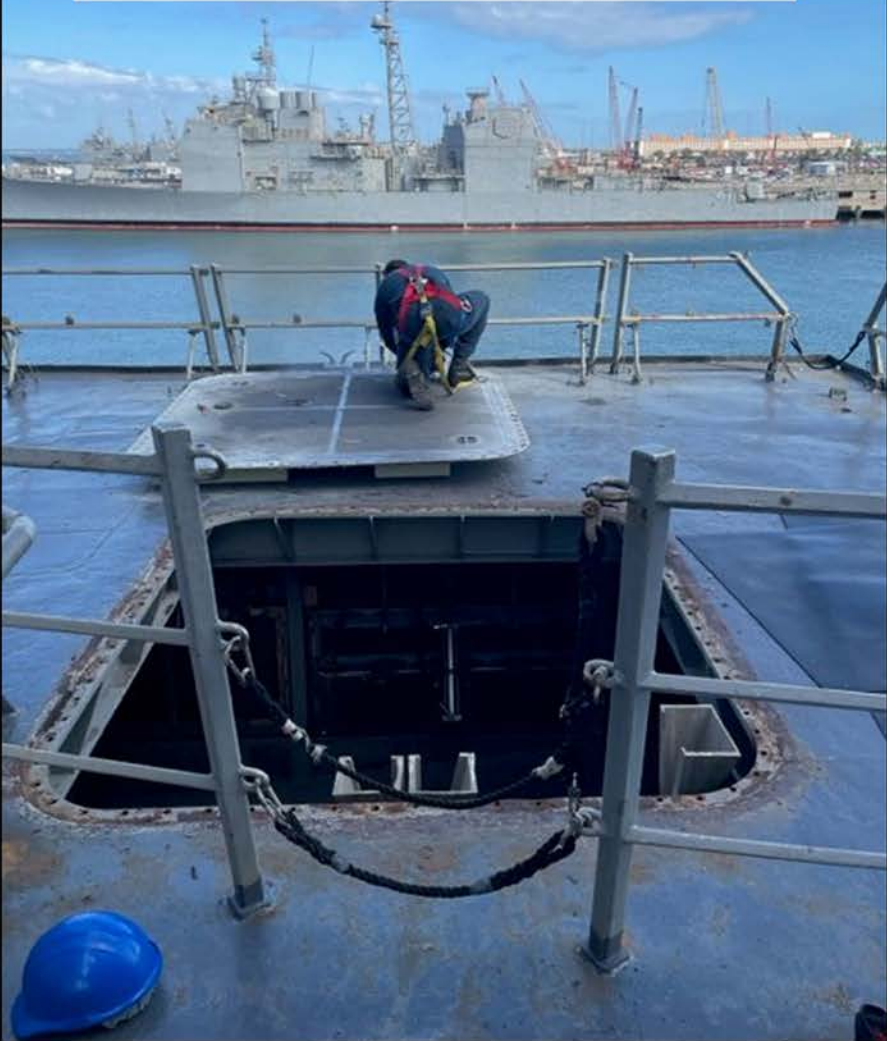
Good on the Sailor for getting after topside corrosion, but notice he's wearing a fall arrest harness which isn't actually connected to anything. Equipment can't perform if it's not used properly. Bonus points for also noticing the removeable nylon lifelines in the foreground, one isn't connected and none of them meet PMS requirements regarding droop.
