DROPZONE

EXPEDITIONARY & SPECIAL WARFARE JUMP SAFETY NEWSLETTER

NAOP KEY FINDINGS AND OBSERVATIONS

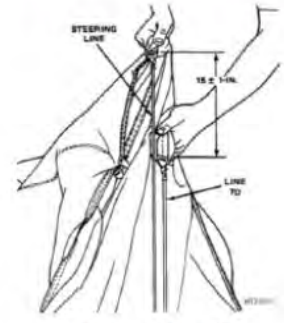
Figure 2 - MT2XX Reserve Canopy

During recent Naval Airborne Operations Program (NAOP) assessments there were varying lengths found on control lines across the board for MT2XX and MC-6 parachute systems. It is important both the reserve and main MT2XX parachute control lines are measured every 182 days. Failure to have the correct line lengths can result in a lack of braking performance during the landing flare sequence subsequently causing injury to the jumper. Figures 1 and 2 are excerpts from the NAVSEA SS400-AX-MMO-010 Rev 2 depicting the procedure for setting the correct measurements:

2. Apply equal tension to both lines and adjust the control line length at the temporary knot secured to the control toggle ring so the control line is 15 inches (+/- 1 inch) longer than line 7D. Secure the control line to the toggle ring with a girth hitch and three half hitches. Repeat this step for the left control line by adjusting the length in comparison to line 1D.

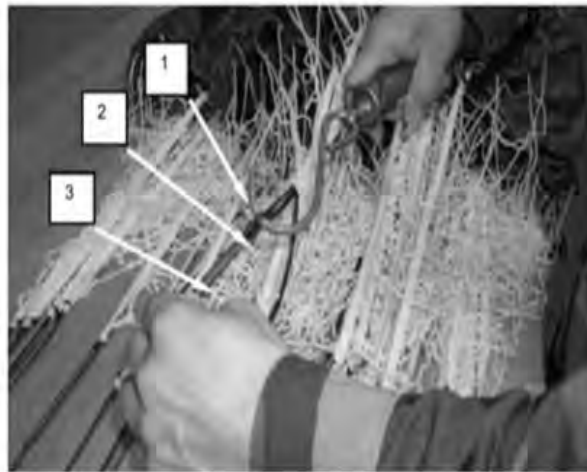
Figure 14. Inserting Scale Hook-end into Girth Hitch.

This requires two rigger personnel to conduct measurement. Using a calibrated scale, measure the lower control lines (left and right) with 14 pounds of tension.

3. Insert the scale hook-end (Figure 14, Item 1) into the girth hitch (Figure 14, Item 2) where the lower control line (Figure 14, Item 3) is attached to the middle control line cascade.

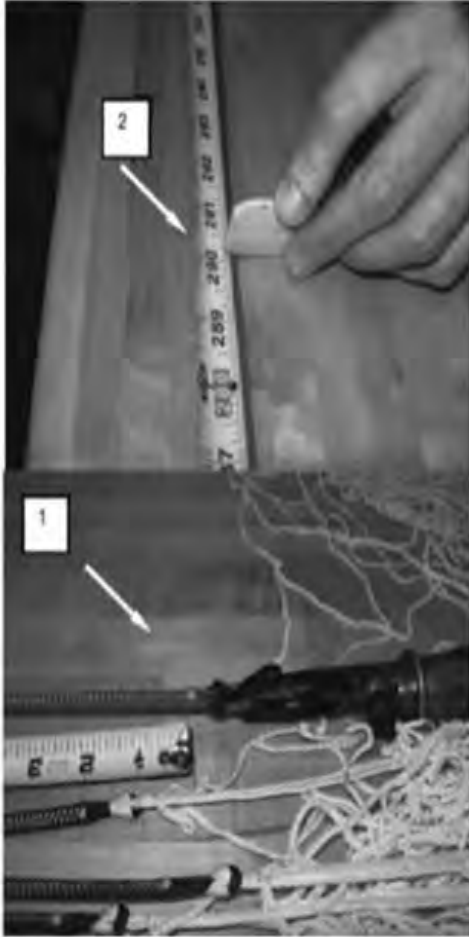
Figure 15. Marking Control Line at 290 Inches.

4. Measure from the top of the zigzag stitch (Figure 15, Item 1) and verify the manufacturer toggle mark is located at 290 ± 1 inches. If the mark is missing, illegible or incorrectly located, mark the control line at 290 inches (Figure 15, Item 2).

1 After the first five jumps have been performed on a new MC-6 main canopy or any new control lines, measure the location of the toggle mark using the procedures above. If the measurement is not 290 ± 1 inch, send the main canopy serial number, number of jumps, initial toggle mark measurement, and current toggle mark measurement to the following: Special Operations Units send to U.S. Army Special Operations Command (USASOC) G-4 CMD Office. All other units send to TACOM-ILSC Military Liaison, Natick, MA.
