DROP^{ZONE}

EXPEDITIONARY & SPECIAL WARFARE JUMP SAFETY NEWSLETTER

ASSESSMENT KEY FINDINGS & OBSERVATIONS

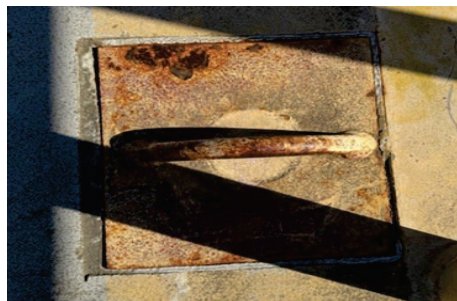
- No up-to-date HRST tower engineering certification for anchor load points.
- Severe corrosion on HRST tower anchor load points.
- HRST tower rope station without a proper guardrail barrier to prevent a fall hazard.

Above, HRST anchor load point. (U.S. Marine Corps photo by GySgt Patrick Doody)

- Ensure HRST towers are inspected and certified by an engineer per MCRP 3-01B.1 Appendix E, OPNAVIST 3500.43 and Marine Corps Order 3500.42.

- Verify the HRST tower certification periodicity has not lapsed prior to use of tower.
- HRST Masters visually inspect towers and verify tower engineering certifications are current prior to each evolution.

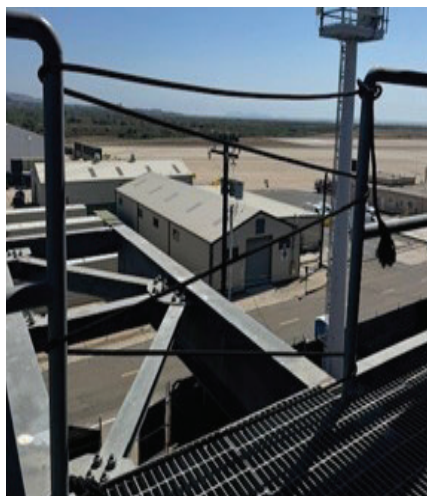
Above, HRST tower access point. (U.S. Navy photo by PRCS Tom Moen)
