SHIP'S SAFETY BULLETIN

FY23
VOL. 6, No. 1

THE OFFICIAL SAFETY NEWSLETTER OF THE SURFACE COMMUNITY

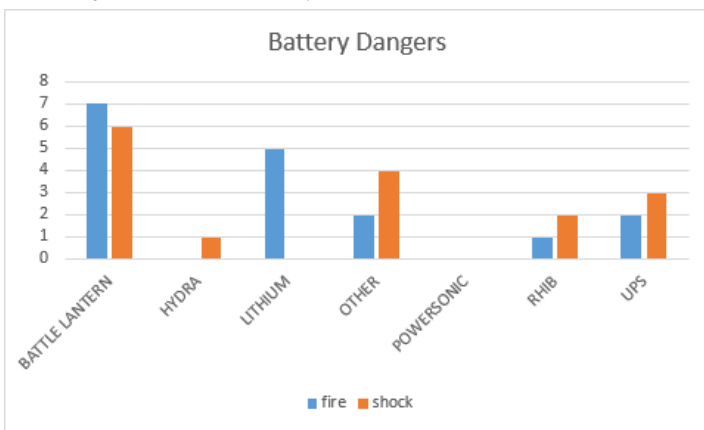
Figure 1 shows the most common dangers associated with batteries are fire and electrical shock. These dangers are most prevalent with battle lantern 6V batteries. The 6V batteries are a required planned maintenance system (PMS) item for damage control lighting systems and must be validated in proper working condition quarterly.

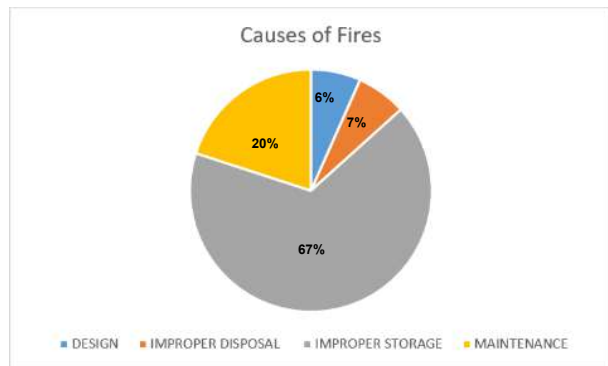
Figure 2

A 6V battery is a lead acid battery type cell that requires the Hazardous Material Minimization Center to containerize used batteries for shore disposal. Improper stowage contributes to most 6V battery fires, as seen in Figure 2.

According to Risk Management Information (RMI) data, Sailors are placing batteries in shop drawers with other items including hazardous material (hazmat), tools, parts and materials to accomplish daily requirements.

It is imperative the negative and positive terminals of the battery do not come in contact with any metallic articles which can cause a fire. When delivered to naval ships, batteries are stored in individual boxes with cardboard partitions between the batteries. Plastic caps are on the leads of each battery to reduce the risk of coming in contact with metal objects. None of the fires reported were located in the ship’s proper hazmat storage or dry storage room in supply. All of these fires were reported originating from inside drawers or cabinets, where Sailors haphazardly placed them.

- NAVSAFECOM recommends leaders focus on checking for improperly stowed batteries during zone inspections and ensure personnel who conduct maintenance using 6V batteries adhere to all procedures and safety precautions as outlined in the Safety Data Sheet Section 7.2: Conditions for Safe Storage and NSTM 670 Appendix E.
- In NSTM 313, the section for lead acid batteries refers back to NSTM 670, which refers to the SDS. Recommend NAVSEA remove the ambiguity on where to find information regarding the proper stowage and handling of batteries in PMS cards by referring to the SDS.

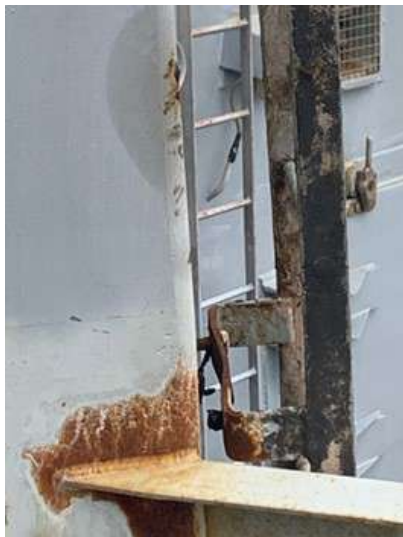
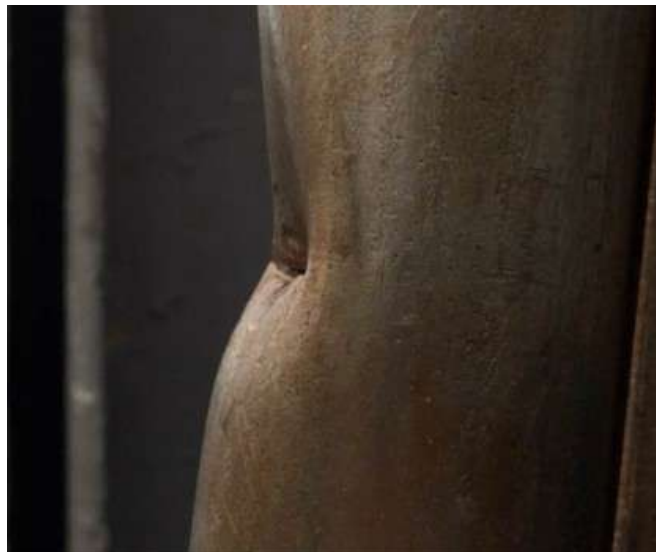
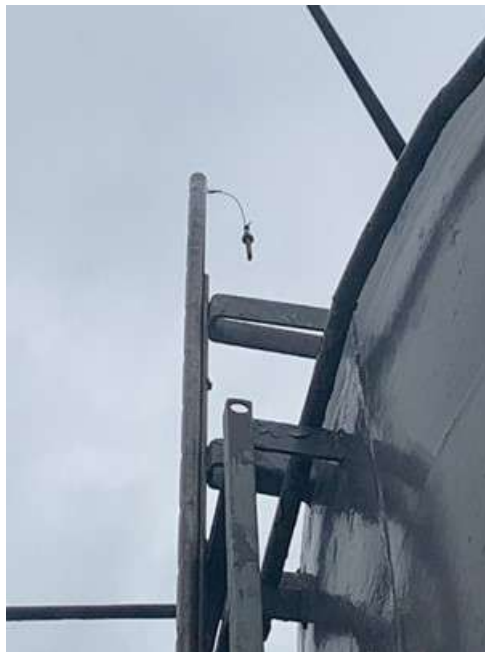
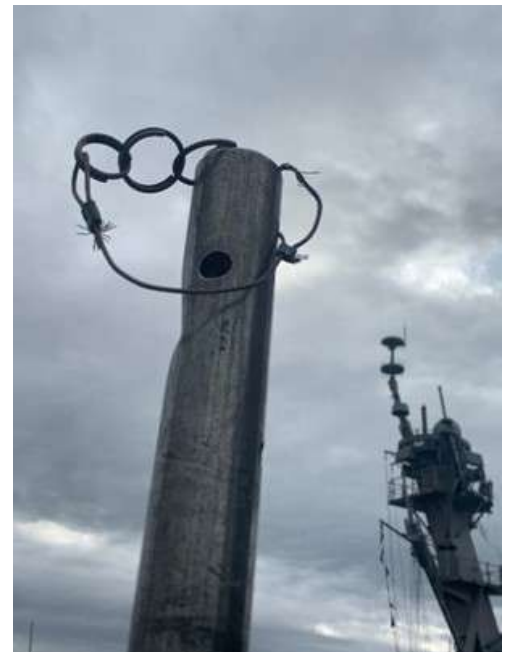
Other discrepancies found throughout the fleet were climber safety rails with excess rust and paint, cracked rails or mounting brackets and missing pin(s) on the top of the rail that prevents the climber safety sleeve from detaching.

Left, crack in climber safety rail

Far left, bracket for ladder rusted off

Bottom, safety pins missing or not installed on top of climber safety rail

These cracks do not necessarily make the climber safety rail unsafe to use, because the climber safety sleeve was designed to catch anywhere on the rail. If cracks are found or welds appear suspect, mark the spot or weld in question to have IMA/Depot-level workers further investigate suspect welds.

climber safety rails, to include the pin installation at the top of the rail. Ensure the maintenance person is checking for cracks in the safety rail and welds, as some have manufacturer defects that NAVSEA is aware of. If found, notify the work center supervisor and tag the climber safety rail out of service per Tag-Out procedures, Tag-Out User's Manual and local tag-out instructions.

The maintenance activity will perform nondestructive test inspection per applicable standards and repair any unsatisfactory weld joint or replace the climber safety rail during the ship's next availability. Retain a copy of IMA/Depot inspections and repairs in Combat System smooth logs and work center logs for future use and historic data.
