# THIS DAY IN NAVAL SAFETY HISTORY

AUGUST 21, 2017

**USS JOHN S. MCCAIN (DDG 56) COLLISION  
10 KILLED, 48 INJURED,  
ESTIMATED OVER \$223 MILLION IN DAMAGES**

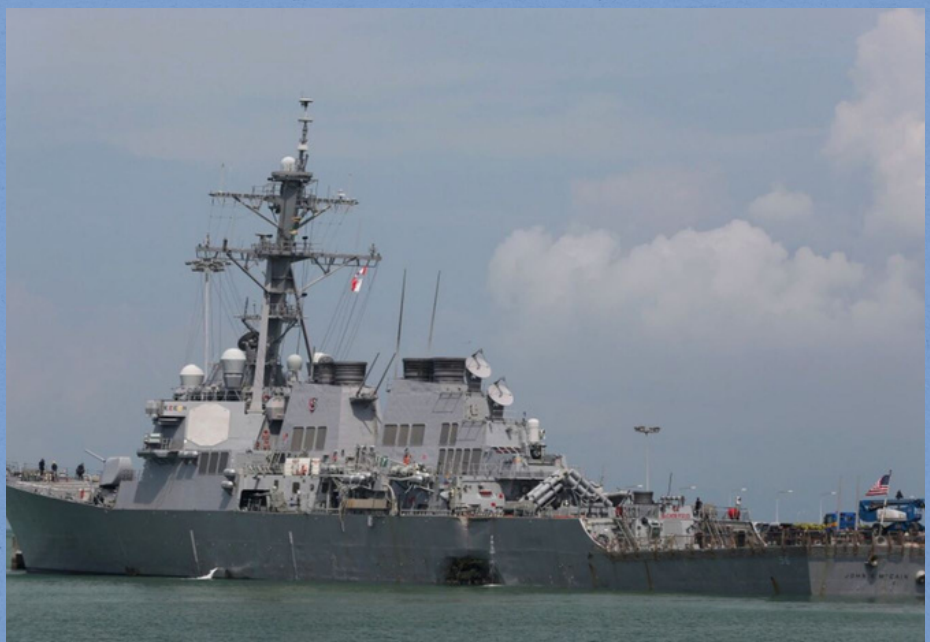
**The destroyer was severely damaged, and some crewmembers initially thought the vessel had come under attack. Alnic MC's bulbous bow struck the destroyer's port quarter at berthing compartments 3 and 5 where Sailors were sleeping. Berthing 5, normally a 15-foot-wide space, was reduced by impact to 5 feet and completely flooded by a mixture of fuel and water in less than a minute.**
