THIS DAY IN NAVAL SAFETY HISTORY

APRIL 22, 2014

USS MCCAMPBELL (DDG 85)

NO. 1 MRG EXPLOSION

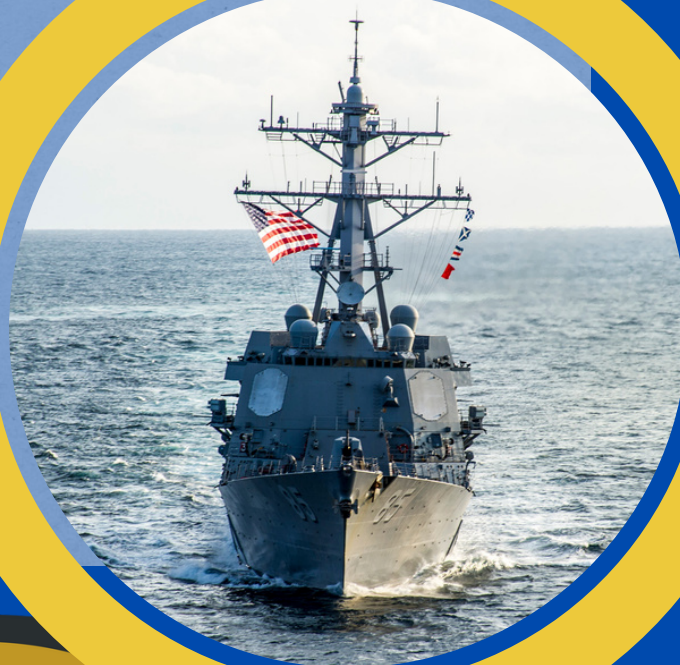
EVENT: :Roughly eight hours after completing routine at-sea operations, the USS McCampbell (DDG 85) was pierside with its Main Engine Room No. 1 (MER1) in shutdown condition when an explosion occurred in the No. 1 Main Reduction Gear (MRG), just after 9 p.m., on April 22, 2014. The explosion caused significant damage to the MRG casing and dehumidifier. Smoke, soot and ashes were found outside the MRG casing indicating flames and heat escaped from blown MRG covers. There were no fatalities.

The first causal factor referred to equipment design flaws in the Lube Oil Purifier Heater (LOPH) which could lead to conditions that overheat lube oil, causing it to break down and release volatile byproduct gases.

- Evaluation of maintenance procedures to include preventive maintenance updates and changes to Maintenance Requirement Card to expand oil testing and clarify procedures, and to the Maintenance Index Pages to improve identification of issues and deficiencies that could contribute to an explosive event.
- Additional Preventive Maintenance System checks to perform routine inspections of certain MRG components.
- Promulgation of warning notification to the fleet on testing procedures and flashpoint procedures and indicators.
