WHAT'S WRONG WITH THIS PIC?

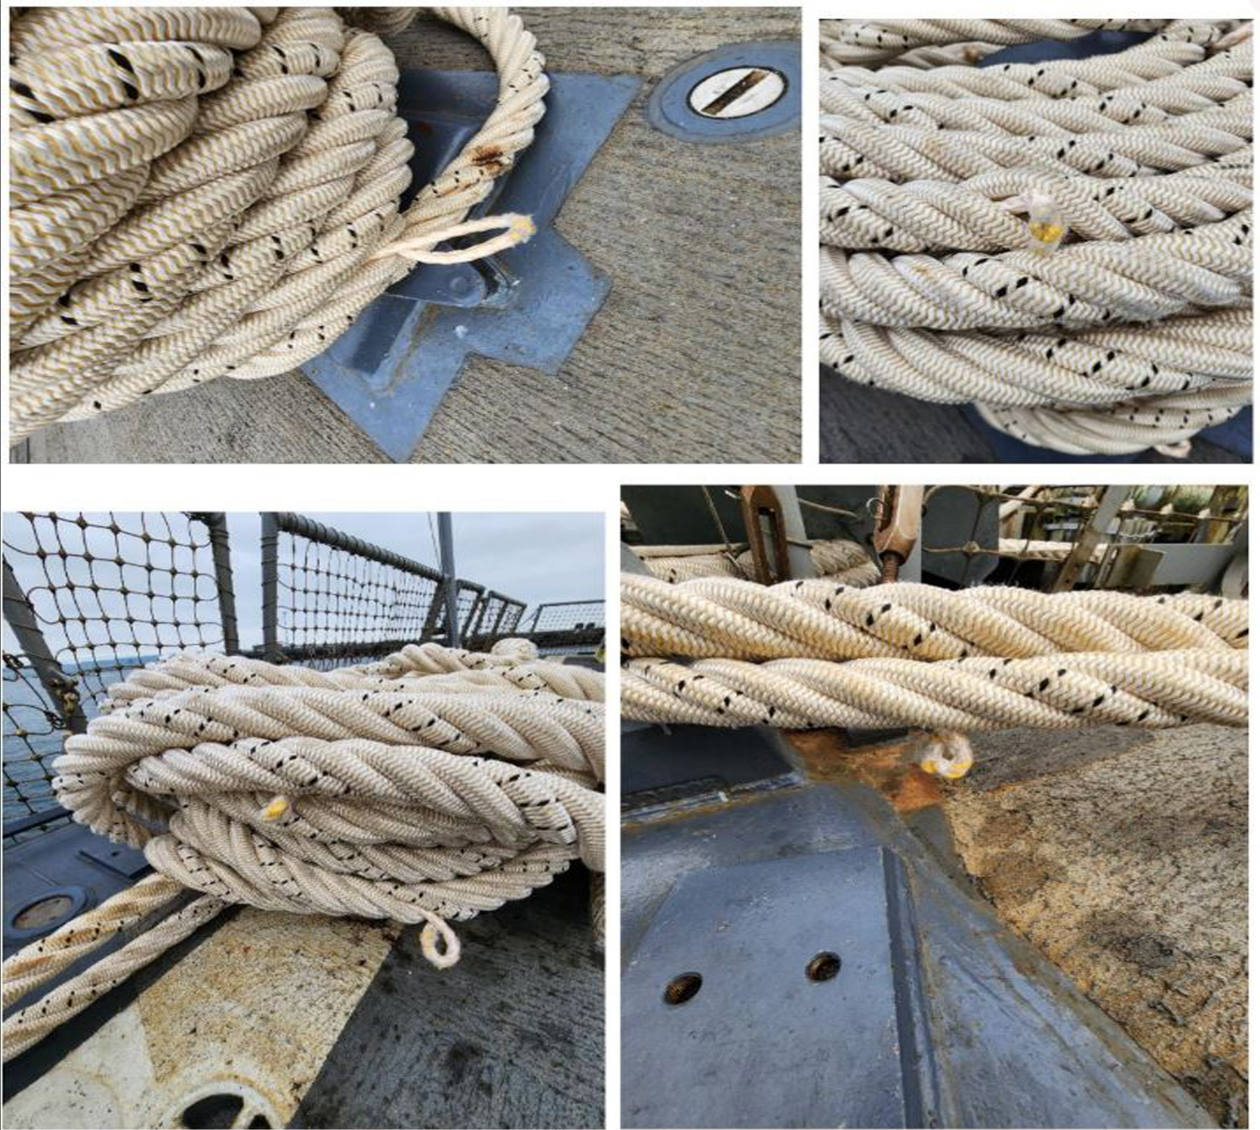
Yes, those mooring lines clearly fail visual inspection in accordance with PMS and the mooring line Tech Manual.

You don’t have to be Captain Obvious to see that these extremely expensive mooring lines are wrong and this situation needs to be resolved ASAP.

Per NSTM Chapter 613, “Wire, Fiber Rope and Rigging”, Rev 5, the correct method for unwinding synthetic lines from spools, faking out on deck for relaxing, and how to bend the new lines onto reels or capstans is specifically described and illustrated. Additionally, direction for fixing cockles is provided, as well. Looks like none of that guidance was followed.
