NAVAL SAFETY COMMAND SAFETY AWARENESS DISPATCH

SA 23-32

USS Saturn Shipyard Fire

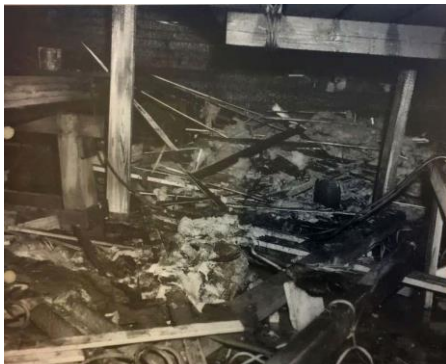
Fire damage in USS Saturn's hold

The fire started in the large pile of cork coated with asphalt enamel and primer and spread rapidly. Fumes and gases from the burning cork overcame the workers who couldn't find their way out or the exits were blocked by fire. The investigation could not determine whether the fire started due to someone smoking near the compartment or from hot work. Regardless, storing highly flammable cork (*or any flammable material*) in the same compartment with welding and cutting in progress is a recipe for disaster.
