THE NAVY AND MARINE CORPS AVIATION SAFETY MAGAZINE

# Approach

VOL. 68, NO. 1

Spring 2026

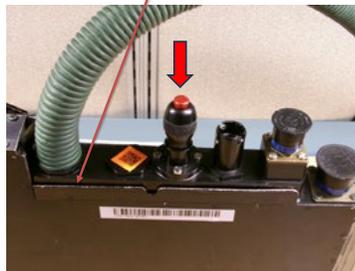
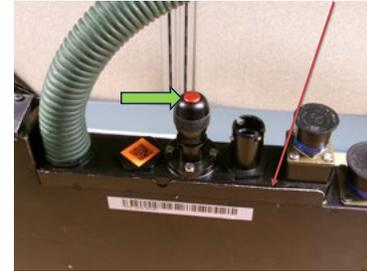
**Disconnected** – Improper seating, red button not clicked in. PIC not flush with SPA.

**Connected** – Properly seated, red button fully pressed in, audible 'click' heard. PIC flush with SPA.

Figure 4. Check the PIC connection if breathing becomes difficult. The red button should be fully pressed in.

A PIC disconnect is a condition potentially interrupting air flow from the OBOGS at the Seat Portion Assembly (SPA). The degree of separation between the PIC and SPA will determine whether or not airflow is completely interrupted. A PIC disconnect is associated with the following ICAWs: CABIN PRESS, OXYGEN CRITICAL, BOS LO, BOS ON, BOS OVERRIDE, OXY FLOW DEGD and PBA FAIL. These ICAWs in conjunction with

difficulty breathing should cue pilots to check their PIC connection (Figure 4).

The F-35 Joint Program Office is currently developing a PIC DISC ICAW to replace the litany of ICAWs currently presented. Because the PIC disconnect increases effort needed to breathe, it is commonly reported incorrectly as hypoxic-like symptoms. This, however, is a misnomer and would more correctly be identified as hyperventilation potentially leading to hypocapnia which presents similar symptoms to hypoxia. If this condition is suspected, it is imperative to check your PIC connection.
