THE NAVY AND MARINE CORPS AVIATION SAFETY MAGAZINE

Approach

VOL. 65, NO. 3

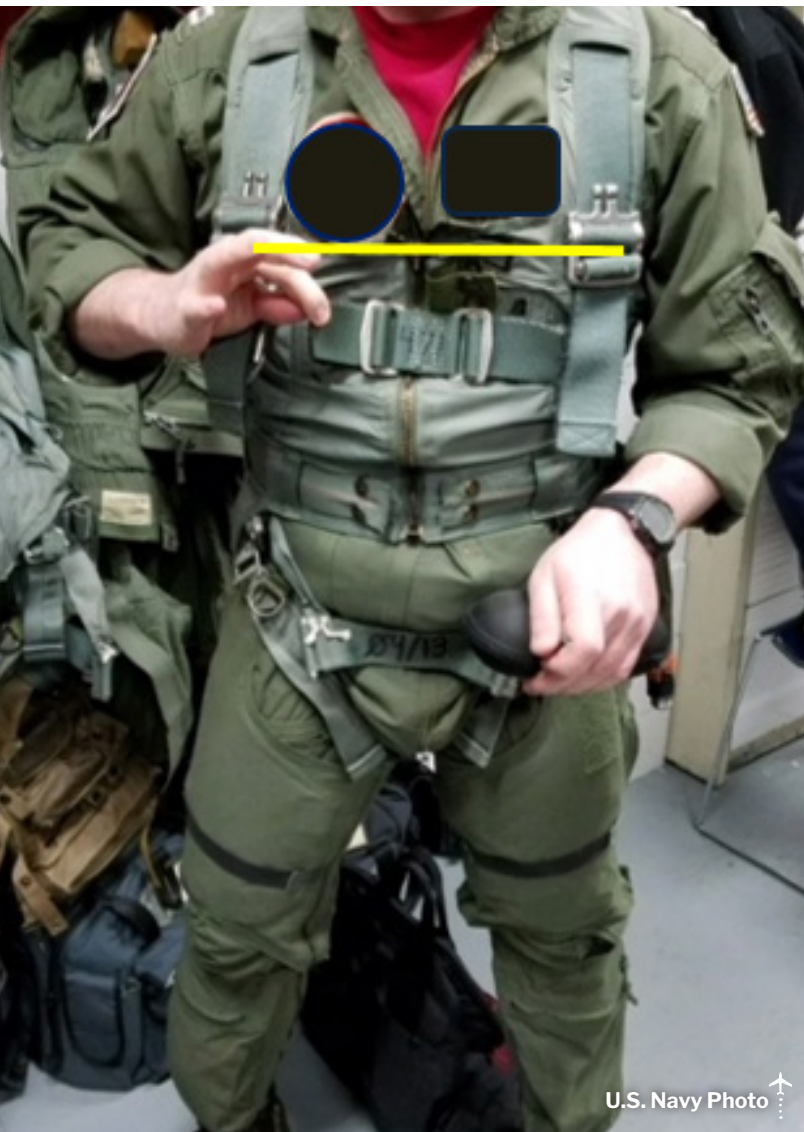
The yellow line indicates proper chest strap position on the parachute harness.

Breathing dynamics in the flight environment are very different in sitting position, G-forces and other human factors. Acceleration atelectasis can be caused by as little as 3 G's and as few as two subsequent 5-G exposures which can reduce your lung capacity by 60%. Breathing high concentrations of oxygen further exacerbates this condition. Another issue in flight is lung compliance, which is the ability of your lungs to expand. A reduction in lung compliance increases your work of breathing and can change your breathing dynamics. Poor posture, an improperly fitted or incorrectly worn parachute harness and expansion of the abdominal bladder in your G-suit can all lead to a reduction in lung compliance and make it harder to fully expand your lungs. All these factors can increase the likelihood of developing atelectasis. Taking deep breaths is an important way to re-inflate collapsed alveoli in your lungs. Maintaining good posture and avoiding the “helo-hunch” will also help with improving lung compliance. Pay particular attention to the fit of your parachute harness as a low chest strap placement will reduce your ability to take deep breaths. Ensure your chest strap is at or slightly above nipple level. Your G-suit must also fit properly to reduce the potential adverse effects it can have on your diaphragm movement. Ensure proper abdominal bladder placement and that you have at least two fingers’ worth of room

between your abdominal bladder and the lower edge of your ribcage. If you gain or lose 5 pounds, get your G-suit re-fitted!
