NAVAL SAFETY COMMAND

SAFETY AWARENESS DISPATCH

SA 23-19

Amphibious Combat Vehicle Mishaps

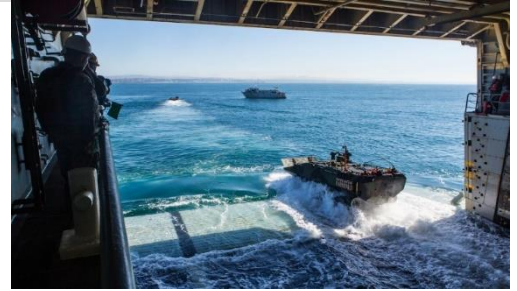
In June 2018, the Marine Corps began procuring the Amphibious Combat Vehicle (ACV). The ACV is designed to transport personnel, equipment and supplies ashore from amphibious shipping; execute ship-to-shore and riverine operations; support breaching of barriers and obstacles; and provide embarked infantry with armor-protected firepower, extended communications and mobility on land and sea.

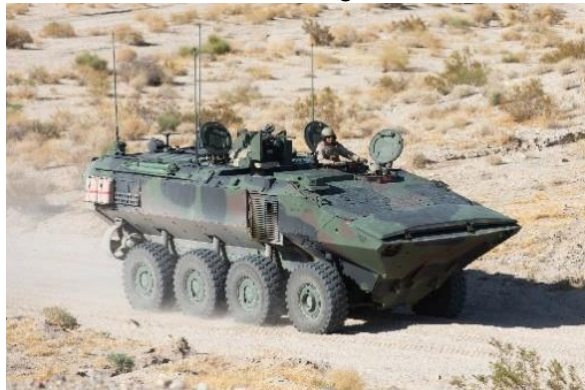
- During an ACV licensing course, a vehicle tipped onto its side while conducting land driving. The driver was utilizing the vehicle's DVE with their hatch closed. While the driver was maneuvering the vehicle on the prescribed course, they approached a turn on the route and failed to reduce speed. The vehicle's excessive speed did not allow the student to sufficiently maneuver it to avoid the side of a hill, so it drove onto the hill, causing the vehicle to tip onto its side. Additionally, the DVE vehicle width indicators on the DVE screen, which present a visual aid for the driver to know where their vehicle is positioned on a road while driving with hatches closed, were found to be out of alignment. —*The increased speed capability of the ACV is a good thing, but not when you don't slow down for a turn. Leave the street racing in movies and treat the ACV like the tactical vehicle it is.*
