SHIP'S SAFETY BULLETIN

FY 2023
VOL. 6, No. 2

Stop the chain of mishaps

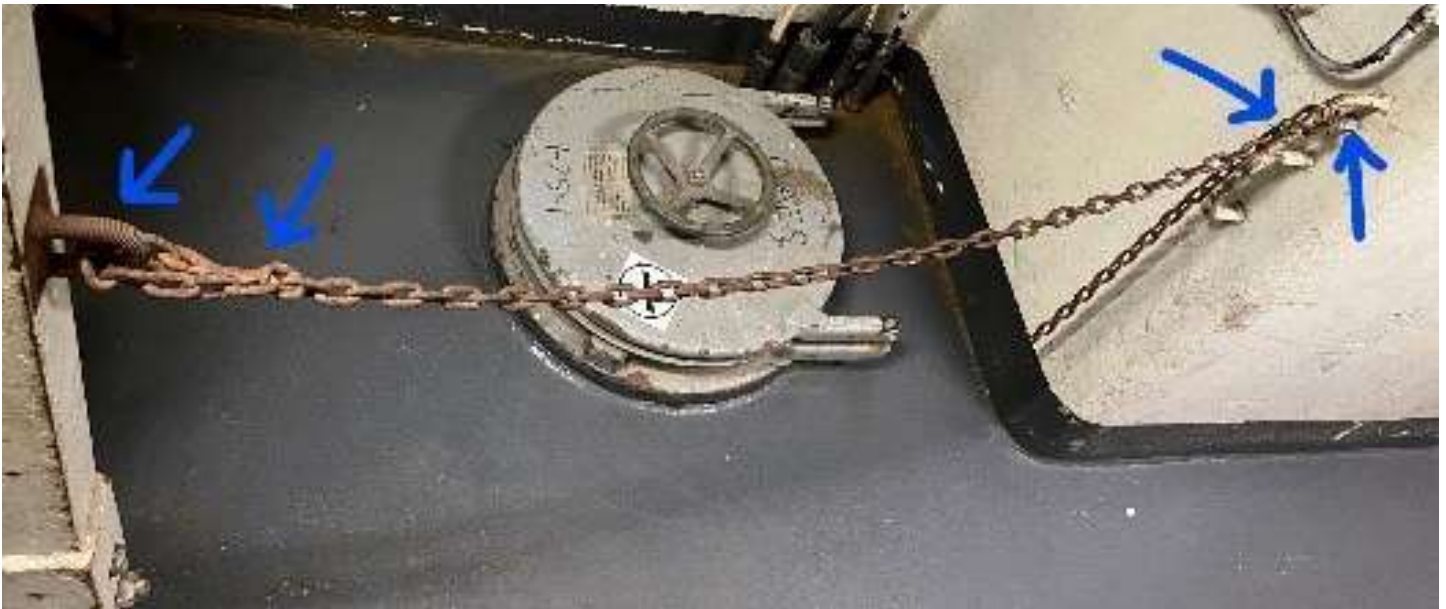
An example of improper installation, maintenance and construction of lifeline chains.

Safety guard installation, maintenance and guidance is spelled out in references (a) through (e). Routinely observed noncompliance with guard lines, such as chains, Kevlar and synthetic lines include the following: guard lines not installed at all or installed improperly, wrong fittings, excessive corrosion and incomplete maintenance

The best way to mitigate potential falling mishaps is to walk your ship and verify all lifelines and guard lines are in compliance and maintained per references (c) through (e) at a minimum. NAVSAFECOM also recommends the following:

- Ensure lifelines and life rails are installed parallel to the deck along deck edges and walkways, around open hatches, elevator openings and antenna platforms. They should also be installed along other boundaries wherever there is danger of personnel falling overboard, falling to lower levels in the ship or becoming enmeshed with hazardous operating machinery.
- Review requirements for constructing lifelines, chains and guards to ensure compliance with Naval Sea Systems Command drawings and NSTM 600, such as two-course-high life rail systems being spaced 21 inches on centers from the deck or three-course-high life rail systems for heavy traffic areas being spaced 14 inches. Unguarded openings shall be kept to a minimum, no greater than 5 inches of opening gap and not exceed 72 inches in length.
- Reiterate to all Sailors at least monthly the importance

As you construct synthetic lifelines and guard lines, always refer back to the NSTM 600 and GSO 612 for proper construction. *Do not* rely on tribal knowledge and the infamous phrase, "This is how we always do it."

Synthetic lines must be made of 5/8-inch line with a 5/16-inch anchor shackle and a 4 5/8-inch snap hook with a weight test of 5,000 pounds. The length of line should be no more than 6 feet, with no more than 3/4-inch slack per linear foot. This will allow the proper catenary or slack for removing the snap hook when required.

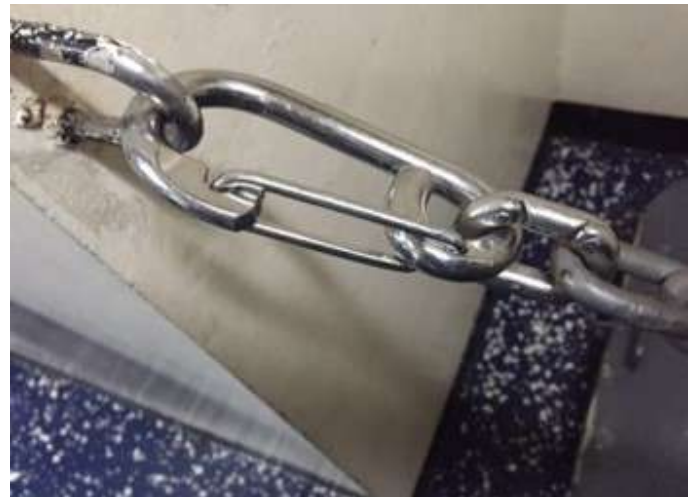
Above: NSN Snap Hook: 5340-01-446-9461; Connecting Link: 4030-00-282-4885.

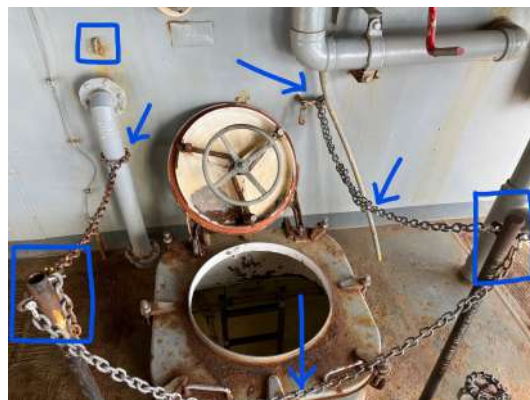
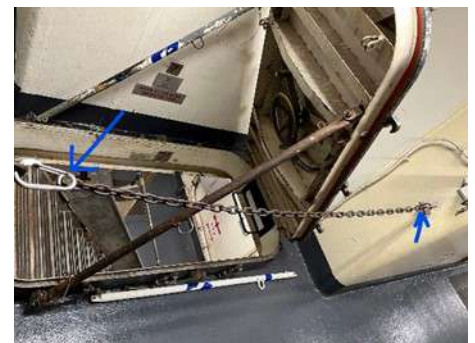
Above, left: Additional examples of improper installation, maintenance and construction of lifeline chains.
