THE NAVY AND MARINE CORPS AVIATION SAFETY MAGAZINE

# Approach

VOL. 67, NO. 1

Summer 2025

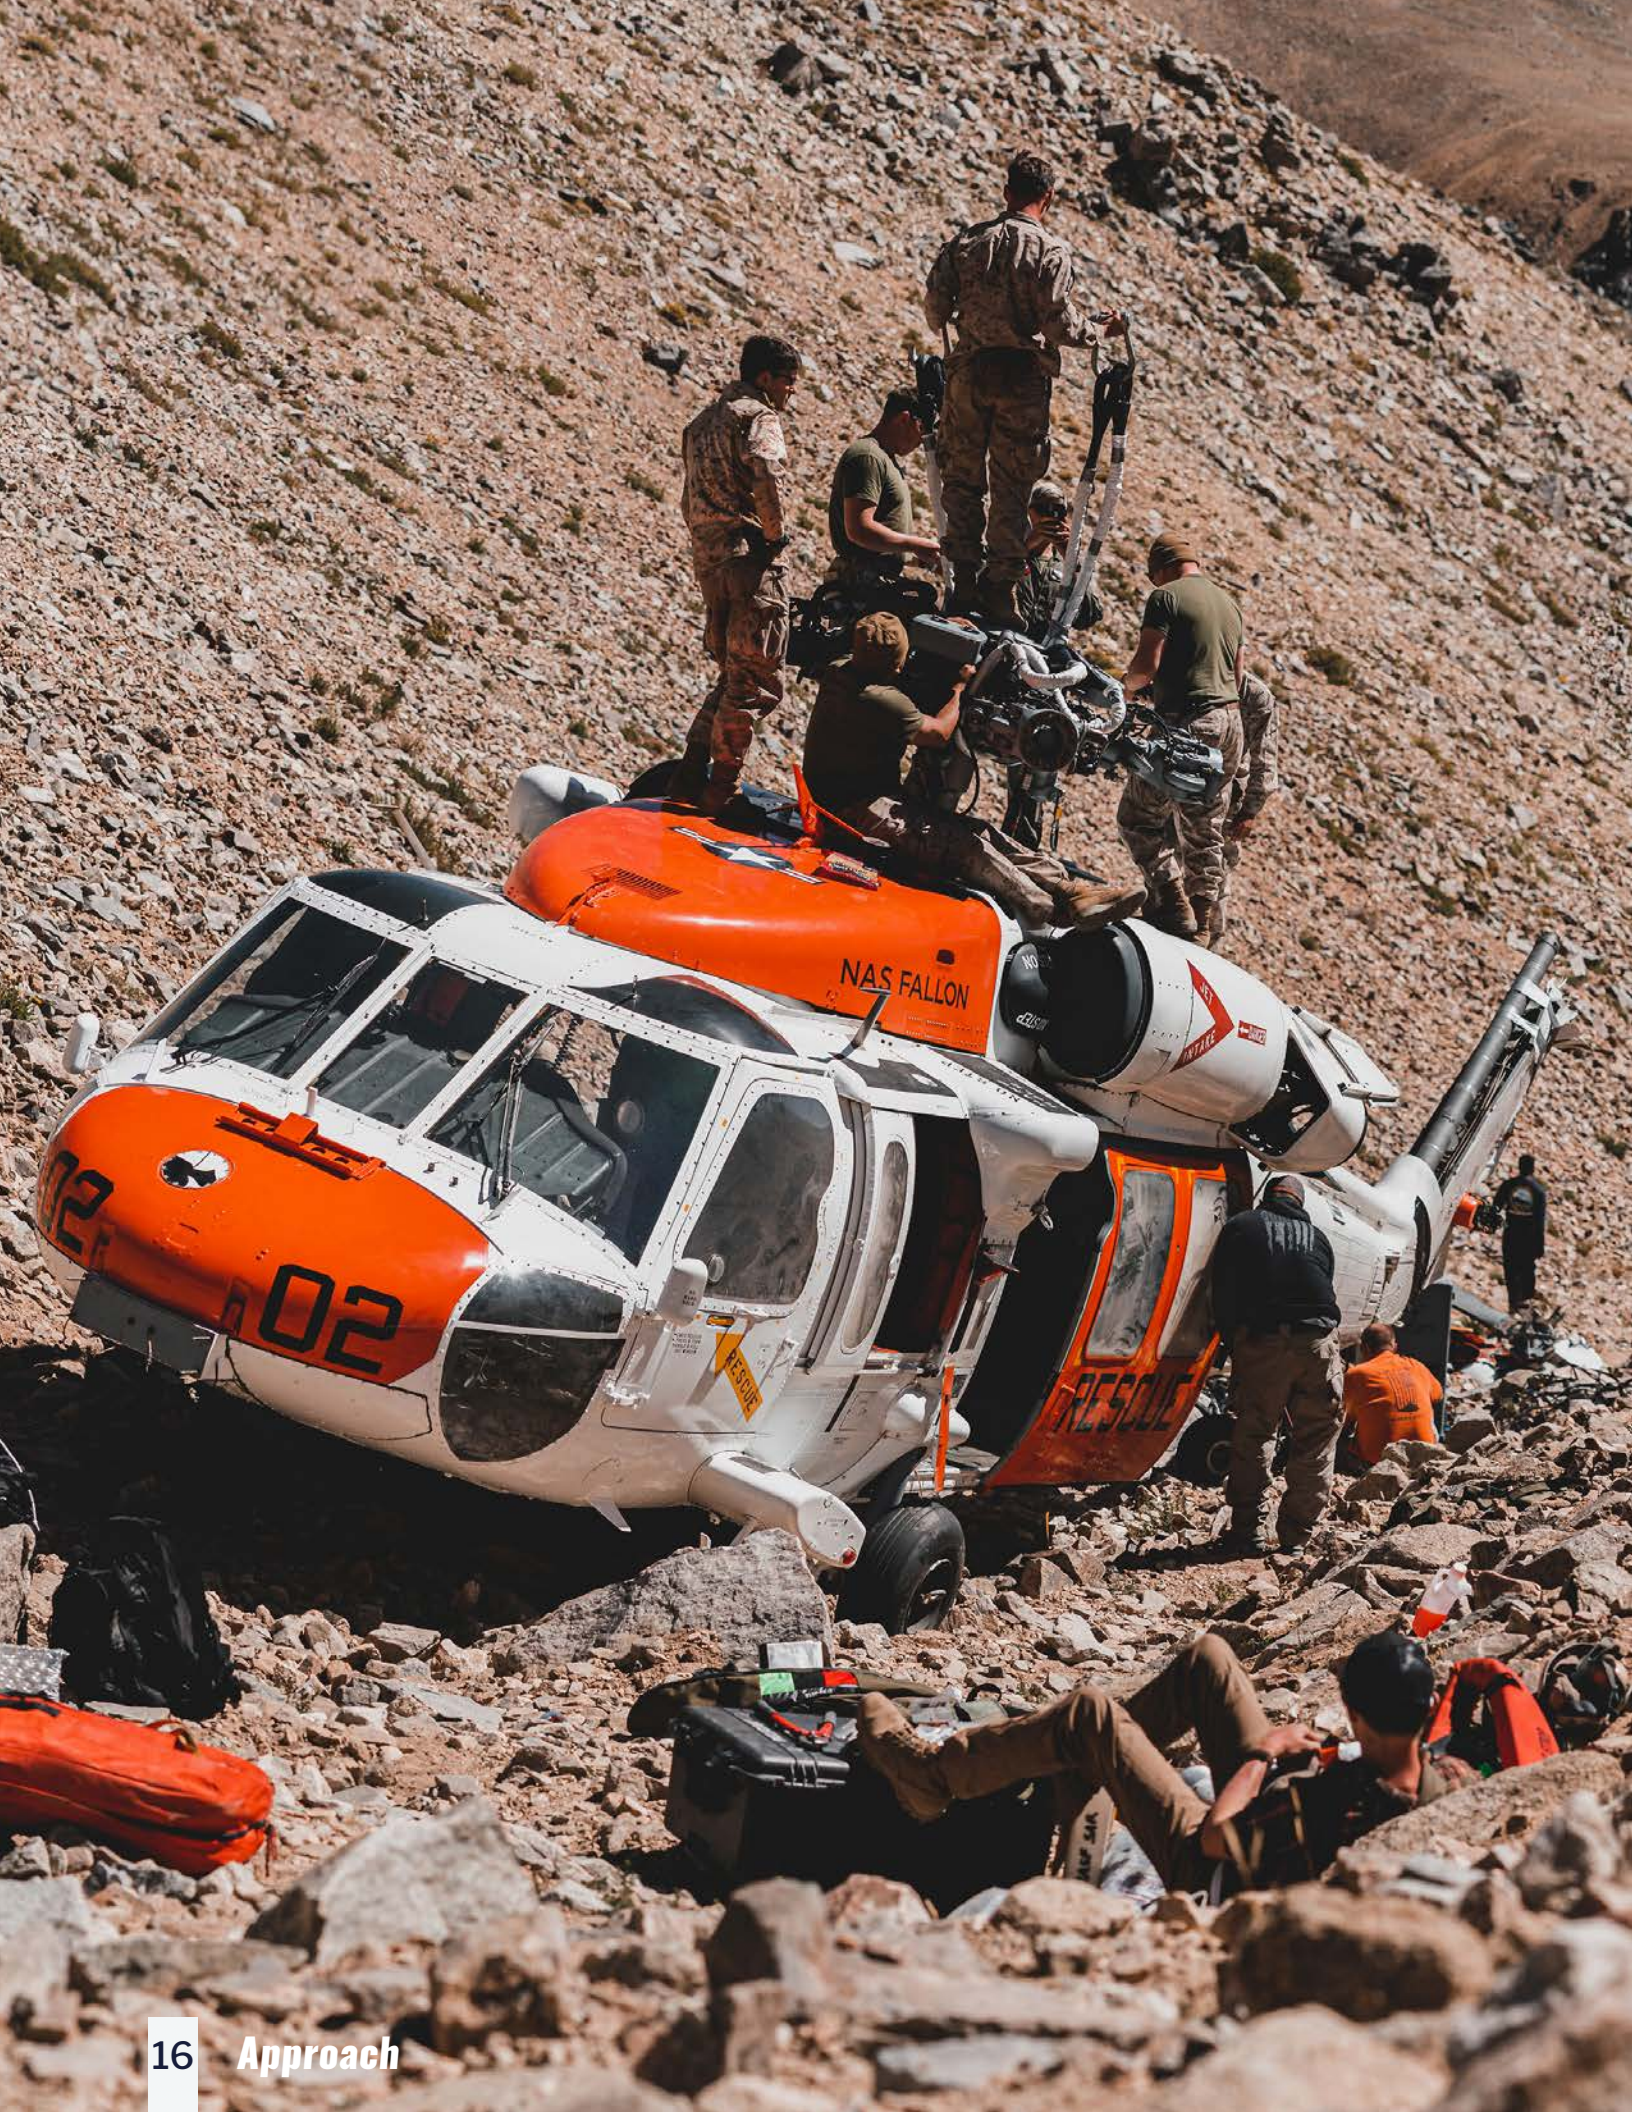
The Swiss Cheese Model is a risk management tool demonstrating layers of active failures and latent conditions. Each slice, or layer, of risk mitigation has holes, representing weaknesses or potential failures. When the holes in each layer align, a trajectory of failure can pass through all the defenses, leading to a possible accident. (U.S. Navy illustration by Ani Pendergast)

In aviation risk management (RM), we often talk about the "Swiss Cheese Model" — meaning there is rarely a single causal factor for a mishap, but rather, a series of minor incidents line up like holes on a stack of Swiss cheese slices and create the conditions for a mishap. At this point, VY 13 was starting to see the confluence of multiple hazards and the aircrew turned to the final approach bearing on their first PAR with some apprehension. Stiff crosswinds during final approach made it difficult for the jet to remain on course. The approach controller opted for large heading changes to quickly address any deviations from course, which made overshoots difficult to avoid. Ultimately, at 800 feet, the controller informed the aircrew of VY 13 they were not in a safe position to land due to course line deviations and they directed them to execute a go around. Still in the clouds without the runway environment in sight, VY 13 executed their missed approach instructions.

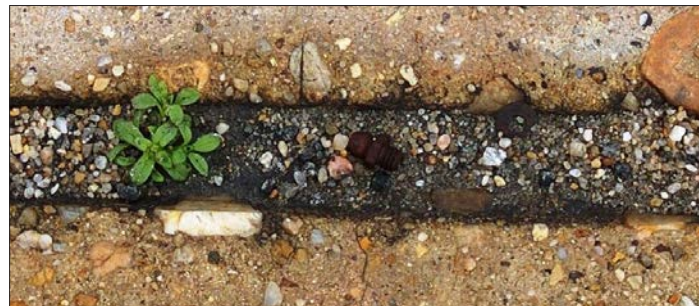
Figure 1. Do you see the bolt, nut and washer? How long have they been there? Long enough to rust! (Photo by Paul Widish)

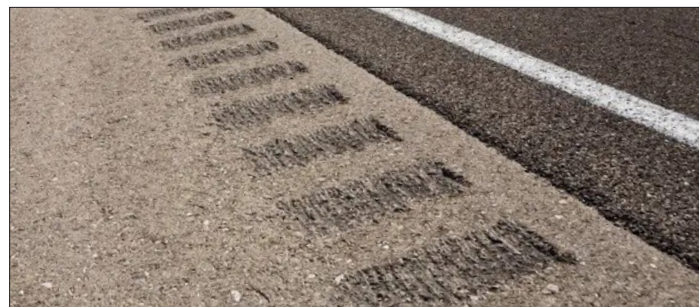
Figure 3. Short milled rumble strips adaptable to airport use. (Photo courtesy of the U.S. Department of Transportation Federal Highway Administration)

The applied science of this pavement modification is not written anywhere in a Unified Facilities Criteria, but the airport safety research for it has already been paid for. If rumble strips are strategically installed at airfield access points at locations where pavement repairs are already approved, it will not cost much extra to provide our airport operational environment with another valuable tool against FOD caused by human failure. ✈
