THE NAVY AND MARINE CORPS AVIATION SAFETY MAGAZINE

Approach

VOL. 67, NO. 1

Summer 2025

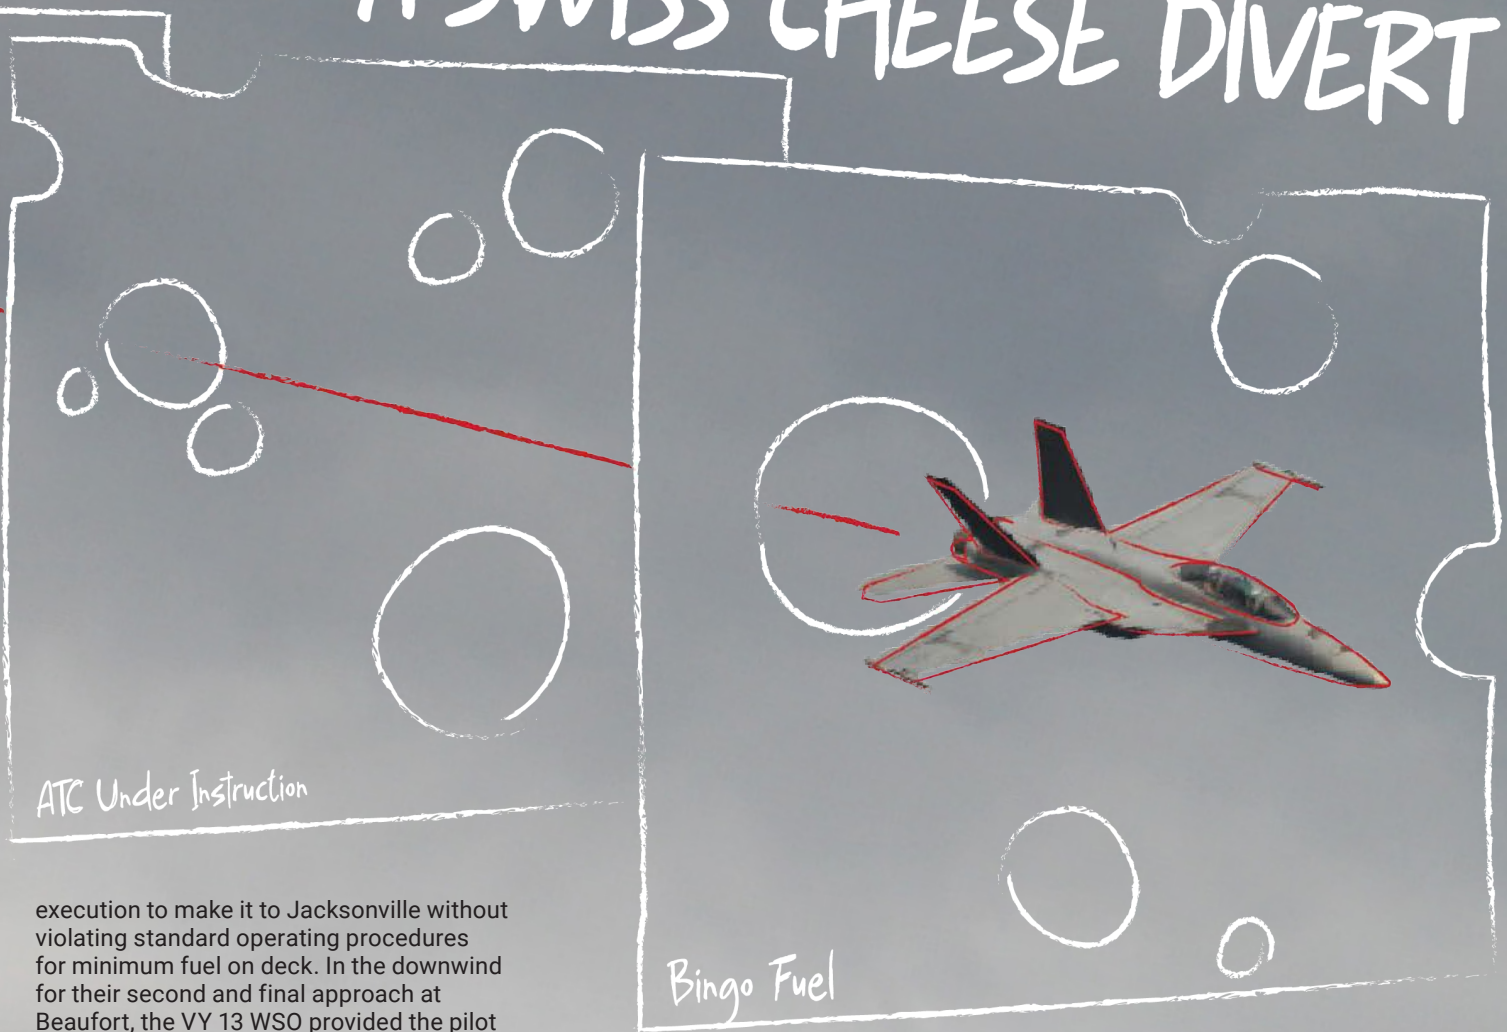
The Swiss Cheese Model is a risk management tool demonstrating layers of active failures and latent conditions. Each slice, or layer, of risk mitigation has holes, representing weaknesses or potential failures. When the holes in each layer align, a trajectory of failure can pass through all the defenses, leading to a possible accident. (U.S. Navy illustration by Ani Pendergast)

In aviation risk management (RM), we often talk about the "Swiss Cheese Model" – meaning there is rarely a single causal factor for a mishap, but rather, a series of minor incidents line up like holes on a stack of Swiss cheese slices and create the conditions for a mishap. At this point, VY 13 was starting to see the confluence of multiple hazards and the aircrew turned to the final approach bearing on their first PAR with some apprehension. Stiff crosswinds during final approach made it difficult for the jet to remain on course. The approach controller opted for large heading changes to quickly address any deviations from course, which made overshoots difficult to avoid. Ultimately, at 800 feet, the controller informed the aircrew of VY 13 they were not in a safe position to land due to course line deviations and they directed them to execute a go around. Still in the clouds without the runway environment in sight, VY 13 executed their missed approach instructions.

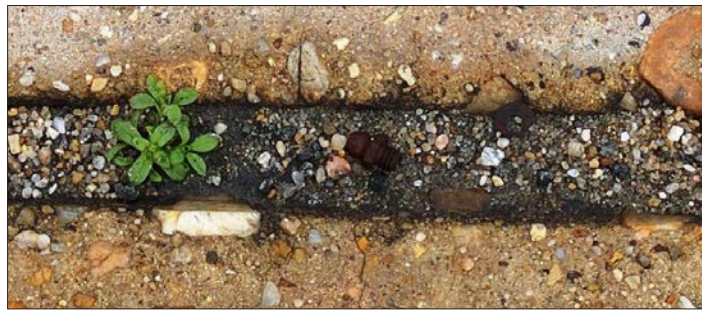
Figure 1. Do you see the bolt, nut and washer? How long have they been there? Long enough to rust! (Photo by Paul Widish)

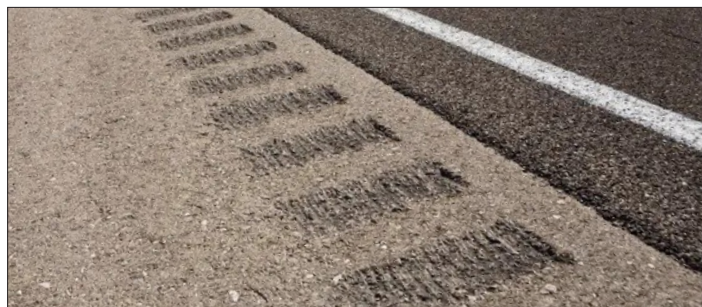
Figure 3. Short milled rumble strips adaptable to airport use. (Photo courtesy of the U.S. Department of Transportation Federal Highway Administration)

The applied science of this pavement modification is not written anywhere in a Unified Facilities Criteria, but the airport safety research for it has already been paid for. If rumble strips are strategically installed at airfield access points at locations where pavement repairs are already approved, it will not cost much extra to provide our airport operational environment with another valuable tool against FOD caused by human failure. ✈
