# Lithium Battery Safety Program

Aviation Safety Board  
26-01

By Master Chief Avionics Technician Will Davis  
Naval Safety Command

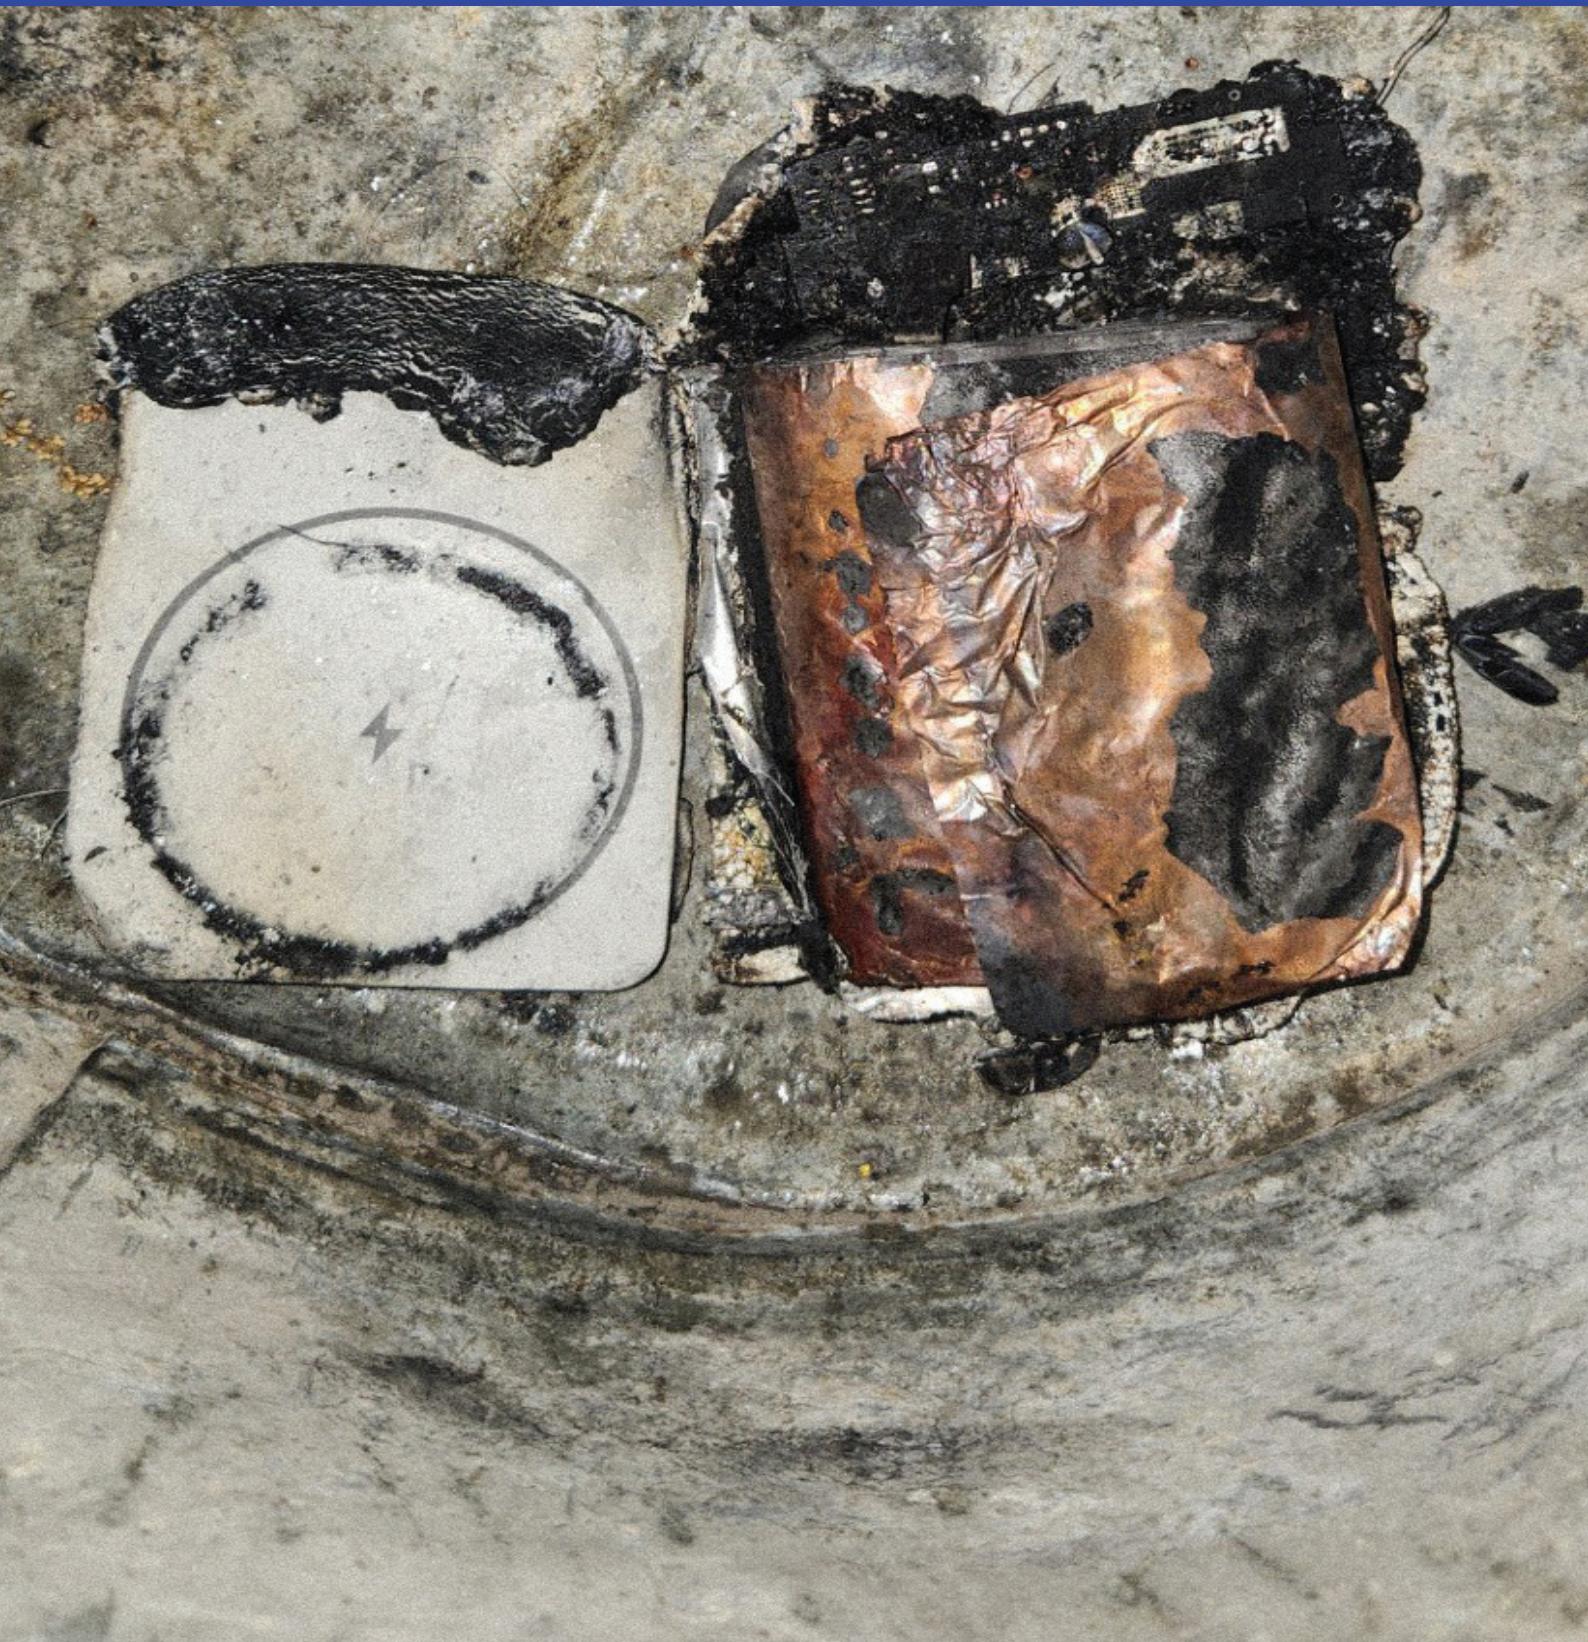
**Cover:** A charging device and battery in the bottom of a metal wastebasket. The lithium battery and charger were placed under a Sailor's pillow, which ignited in the middle of the night. The Sailor's personal belongings were damaged, no injuries to the Sailor and the fire was contained.

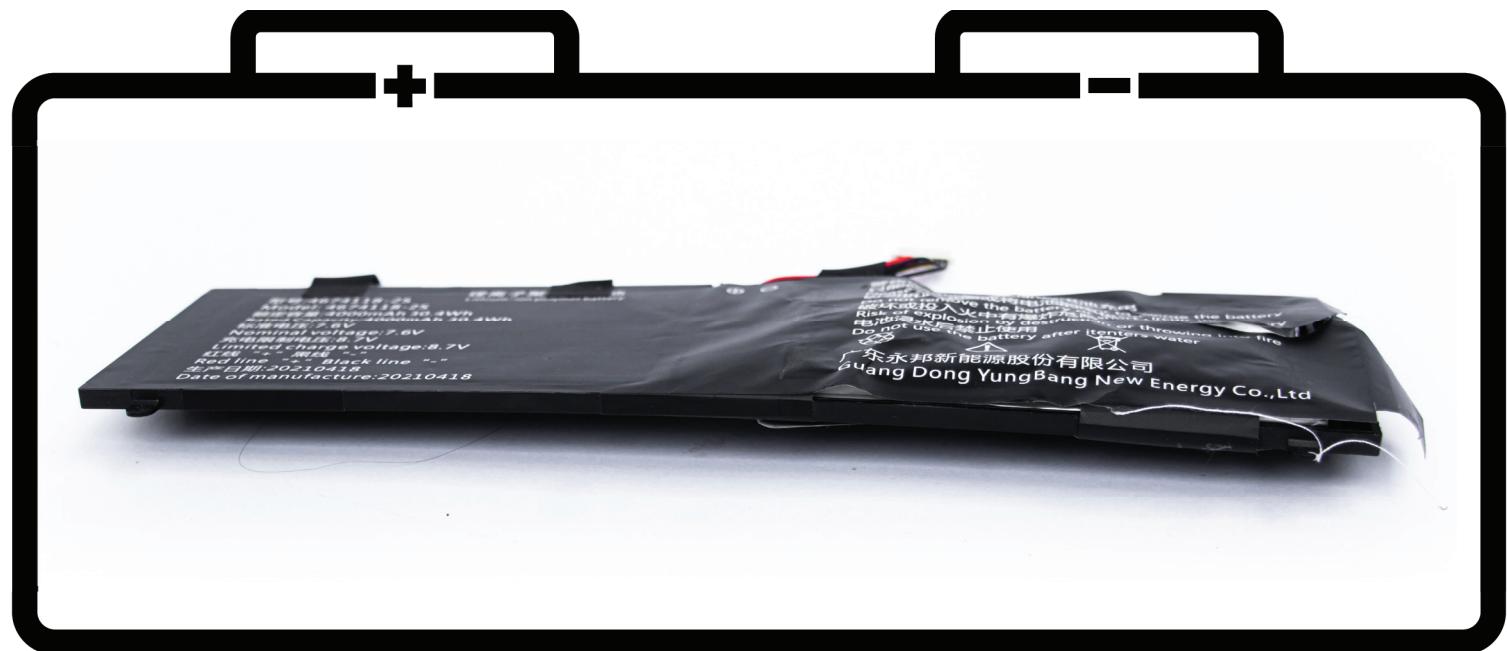
**Above:** A failed lithium battery. All lithium battery-related mishaps, near misses, incidents, failures, non-mishap venting or malfunctions must be reported to the Lithium Battery Certification Authority via email: LIBATTS@navy.mil.

If anything appears wrong with lithium batteries, such as indications of leaking electrolytes, bad odors or visual indications such as discoloration, bulging, cracking or deformation, report it to the LBCA. Additionally, some failures in lithium batteries can create an audible ping once the battery has started to relieve pressure. Every command must report non-mishaps associated with lithium batteries to allow NAVSEA to refine the risk assessment associated with the storage and use of lithium batteries.
