MOORING LINE CHAFING GEAR

MISTREATMENT OF MOORING LINES IS AN ELEVATED RISK TO FLEET

AFLOAT SAFETY, NAVAL SAFETY COMMAND - Keeping our sea warriors informed and ready

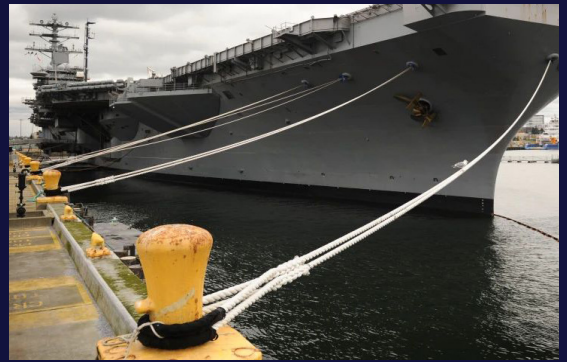
The mooring line is damaged or chafed as it rubs a rough surface. In natural lines, chafing appears as a fuzzy texture or broken yarns hanging down. In synthetic lines, chafing is a hard outer layer. Chafing gear that covers the full range of motion of the ships movements prevent damage.

Without chafing gear, excessive abrasion and cutting of the line can take place; this in turn will cause a loss of line strength and eventual failure.

Naval Ships' Technical Manual (NSTM), Mooring and Towing, Chapter 582 offers a list of various recommended chafing gear.

- Old or discarded fire hoses
- Commercially produced chafing gear
- Smaller line such as 6-thread
- Rags
- Heavy canvas wrapping
- Leather
- Rubber

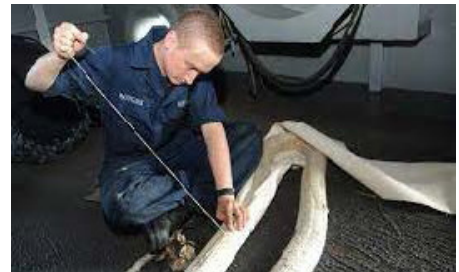
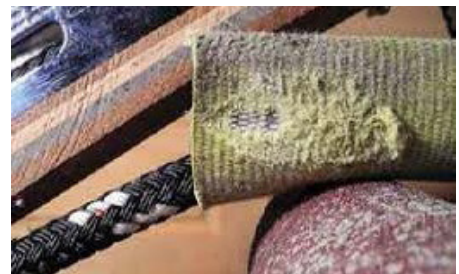
In order to properly protect mooring lines, an adequate length of chafing gear should be installed in areas where the line could rub against rough surfaces. Continuous monitoring of chafing gear placement should take place to ensure that the gear remains in place and is effective throughout high and low tide intervals, as well as periods of adverse weather.

Chafing gear should be installed:

1. Where the eye of the mooring line makes contact with the mooring fitting.
2. Where the mooring line passes through a chock, or along a sharp edge.
3. On fixed objects, along sharp edges that are in contact with a mooring line.
4. Where contact is possible with the edge of a concrete pier or any obstruction during tidal changes.

1. Deck leadership should be familiar with all references and requirements regarding mooring line care and the installation of chafing gear and train junior Sailors to do the same.
2. Duty section personnel such as the CDO, OOD and deck personnel should conduct routine visual inspections of mooring lines and installed chafing gear to verify its effectiveness. This is most critical during tidal changes and adverse weather.
