B
L
U
F

Ground Tackle Precautions (NSTM 581):

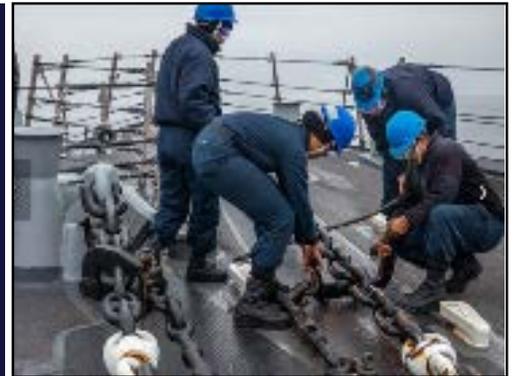
- Ensure all personnel wear snug-fitting clothing, safety goggles, gloves, safety helmets and steel-toed shoes.
- Conduct prechecks on equipment to ensure it is in proper operating condition.
- Keep hands and feet off, and away from moving anchor chains and ground tackle appendages.
- Allow only the Anchor and Line Details in the ground tackle area during operations; ensure all non-essential personnel remain clear.
- When dropping anchor, DO NOT let the chain take charge; control speed by use of hand brake or lowering the anchor under power.

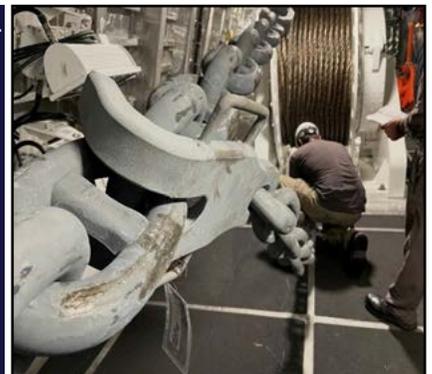
- Recent innovations in anchor configurations, such as the engineering design for the LCS-2 Class, present unique safety challenges.
- Naval ships equipped with the devil's claw or pawl-type chain stoppers use a split hook that engages the end of a horizontal chain link. A primary disadvantage of the devil's claw chain stopper is the inability for the chain to be safely and quickly released while under tension.
- Personnel should NEVER transit forward of the anchor winch drum without the brake set and pawl engaged.
- Safety Observers need to pay close attention to chain/wire tension prior to release of the devil's claw to prevent potential injury to personnel.
