Shipboard Flooding

It's Hullways Something

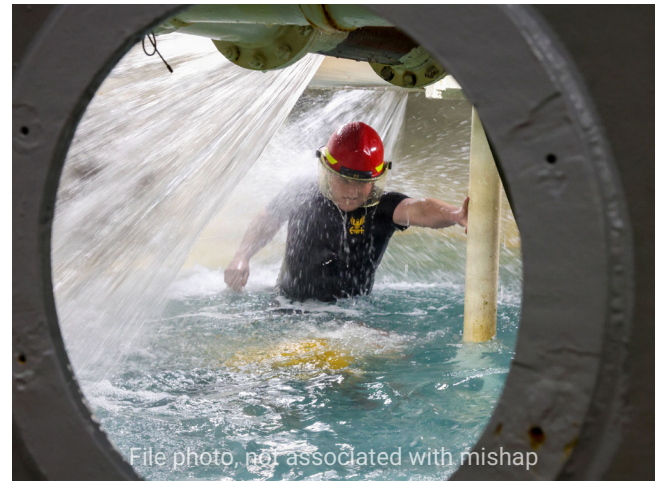
Fresh out of the yards, a naval ship was underway conducting ballasting operations. A person with relatively high experience developed detailed stability and ballasting plans – all in compliance with regulations. All ballast tanks were surveyed during the ship’s dry-dock maintenance availability period three months before the underway. For two days, flowthrough ballast water exchanges were conducted on seven tanks, and, per the approved ballast plan, everything was “as expected.” Then it started. Ballasting exchanges began early in the morning. After correctly aligning the ballasting system IAW proper procedure, the watchstander noted an unexpected minor list and took corrective action to return the ship to an even keel. *(It’s unclear whether the ship took action to investigate the cause of the list or simply applied a correction to fix the symptoms.)* Two hours later a high bilge alarm activated. *(Wait a minute, ballast water goes into ballast tanks or overboard, not into the bilge.)* Flooding of 5-6 inches was quickly discovered. Despite initial-response efforts, flooding continued to increase, and, 30 minutes later, the water was 8-inches deep. Shortly thereafter, the cause of the flooding was identified, and a box patch was applied, reducing the leak to barely a trickle. – *The root cause of the flooding was later determined to be a rusted check valve, which was initially scheduled for overhaul/replacement during the previous maintenance availability. In order to reduce the overall cost of the availability, this work was downgraded to a simple cleaning. It is unclear from the investigation whether that work was actually accomplished. Post-mishap the check valve was found heavily corroded; you can make your own assessment. This mishap clearly shows that the material condition of a single valve can put the ship at risk.*
